An Integrated Approach to Slope Stability Monitoring

Slope Stability Monitoring during Construction

- This project entails monitoring a monolith while the top is being blasted for the construction of a seven-star hotel.
- The presentation will focus on the slope stability monitoring part of this project

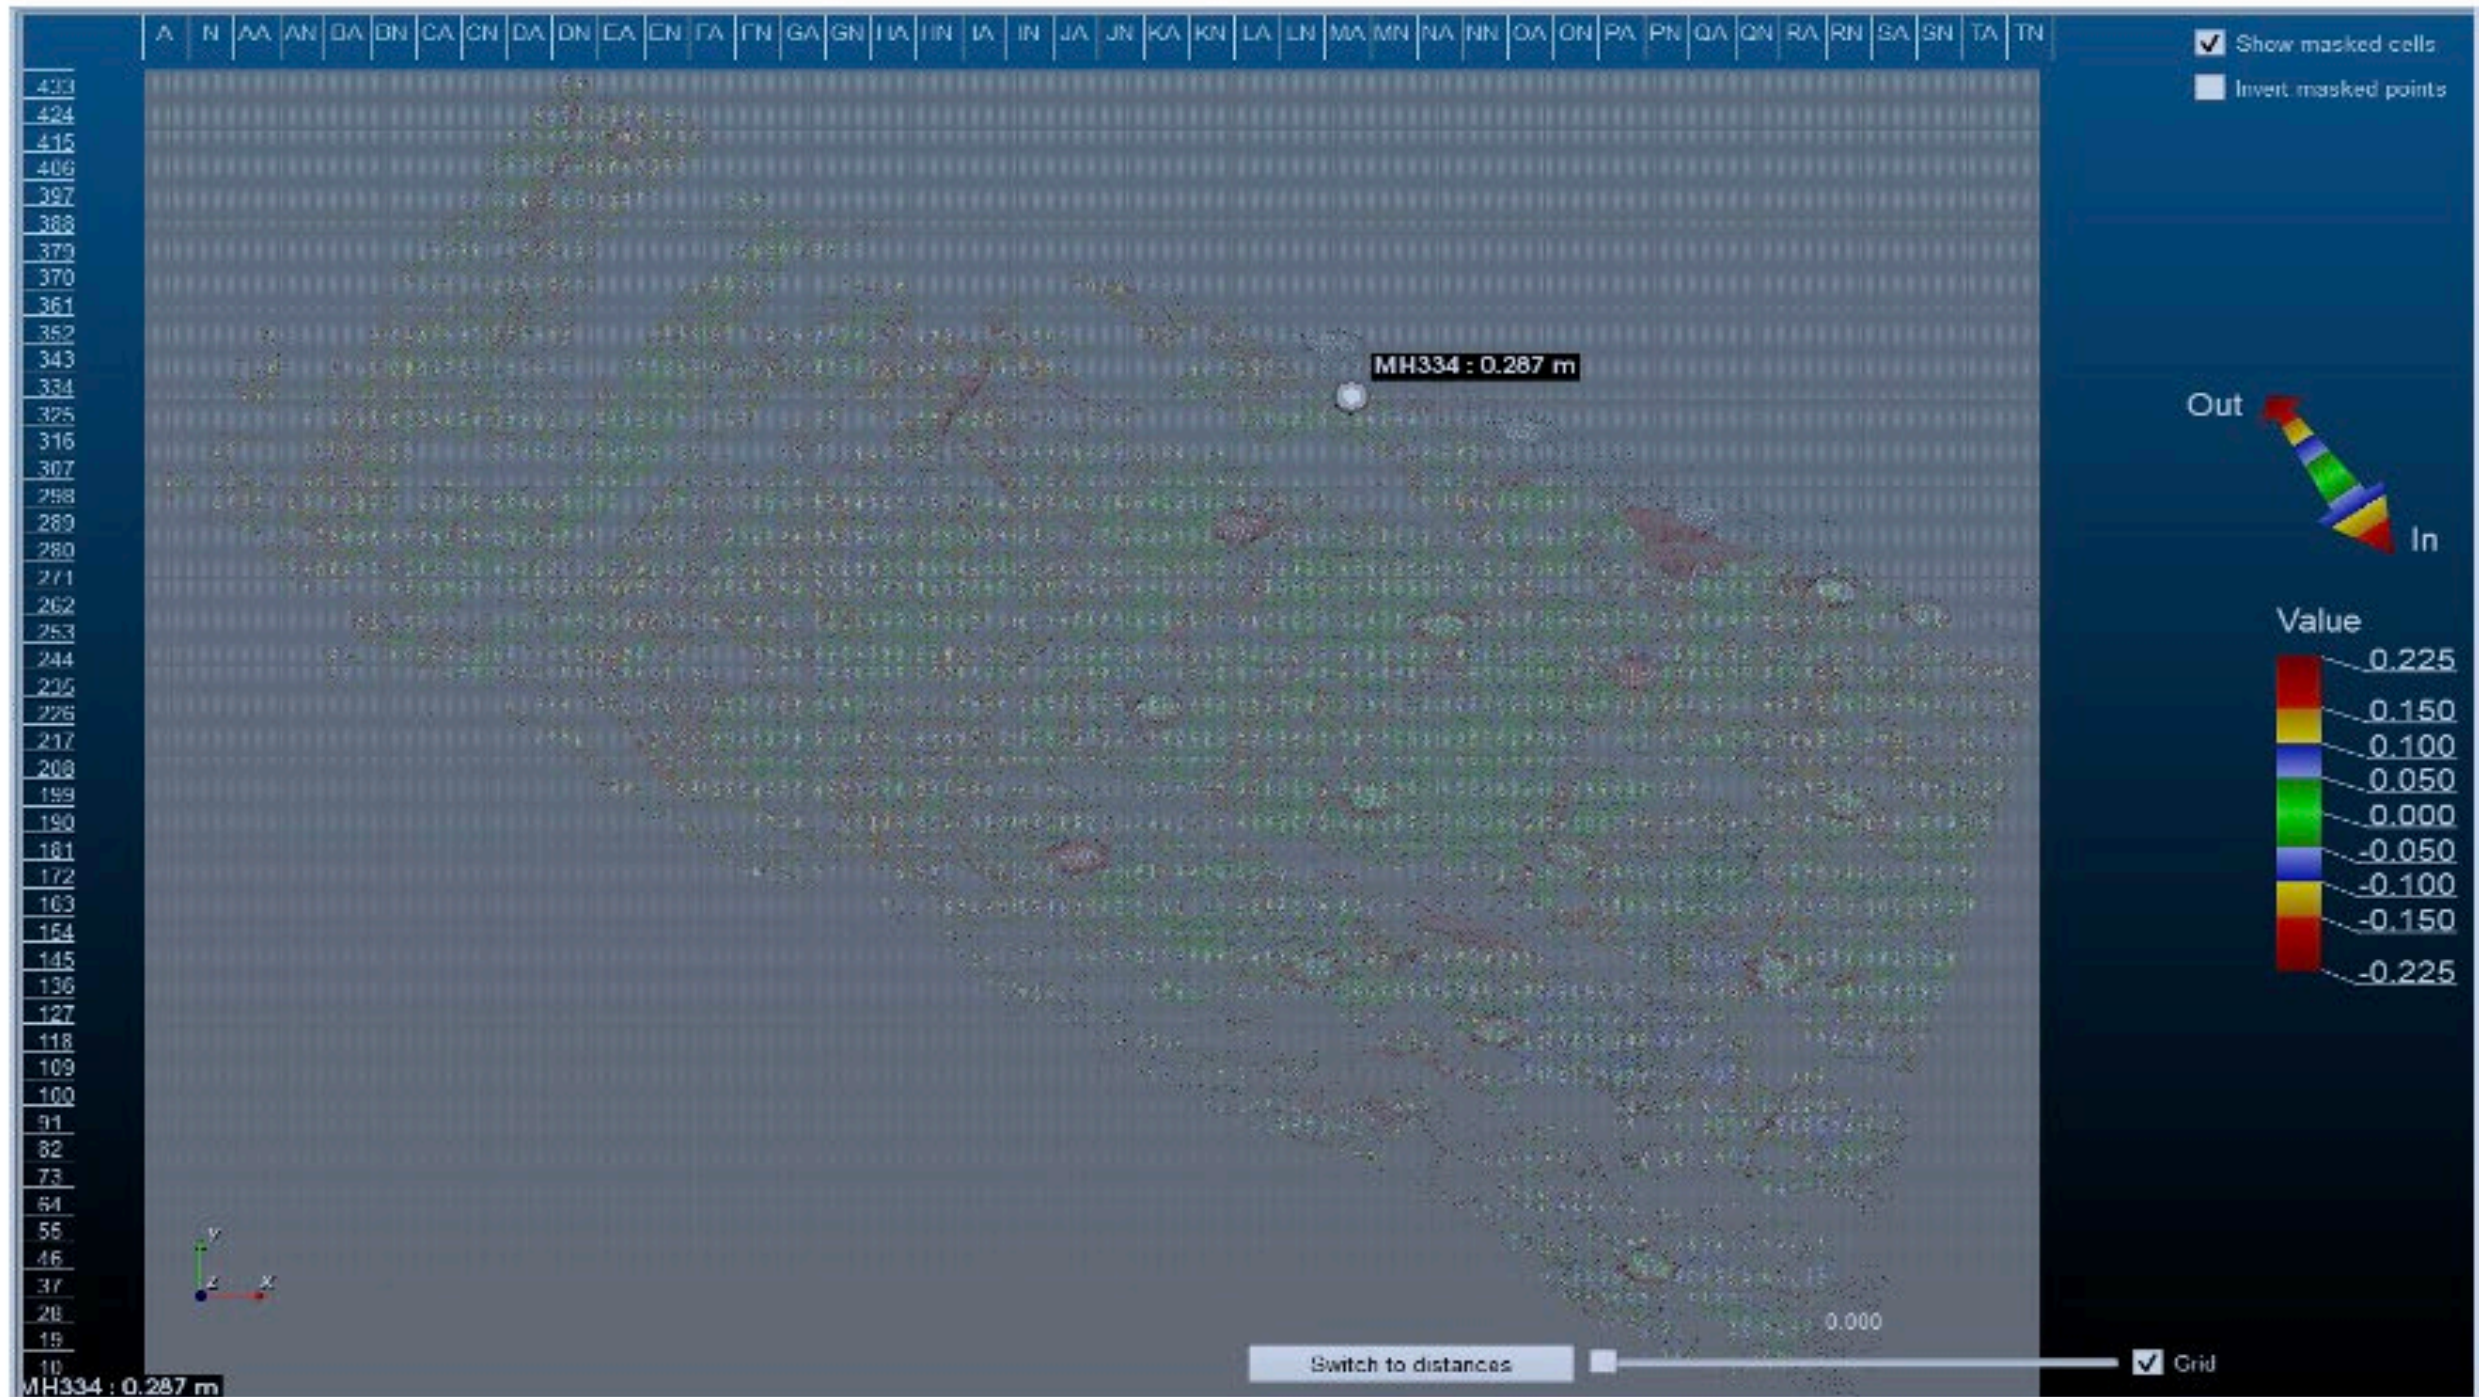
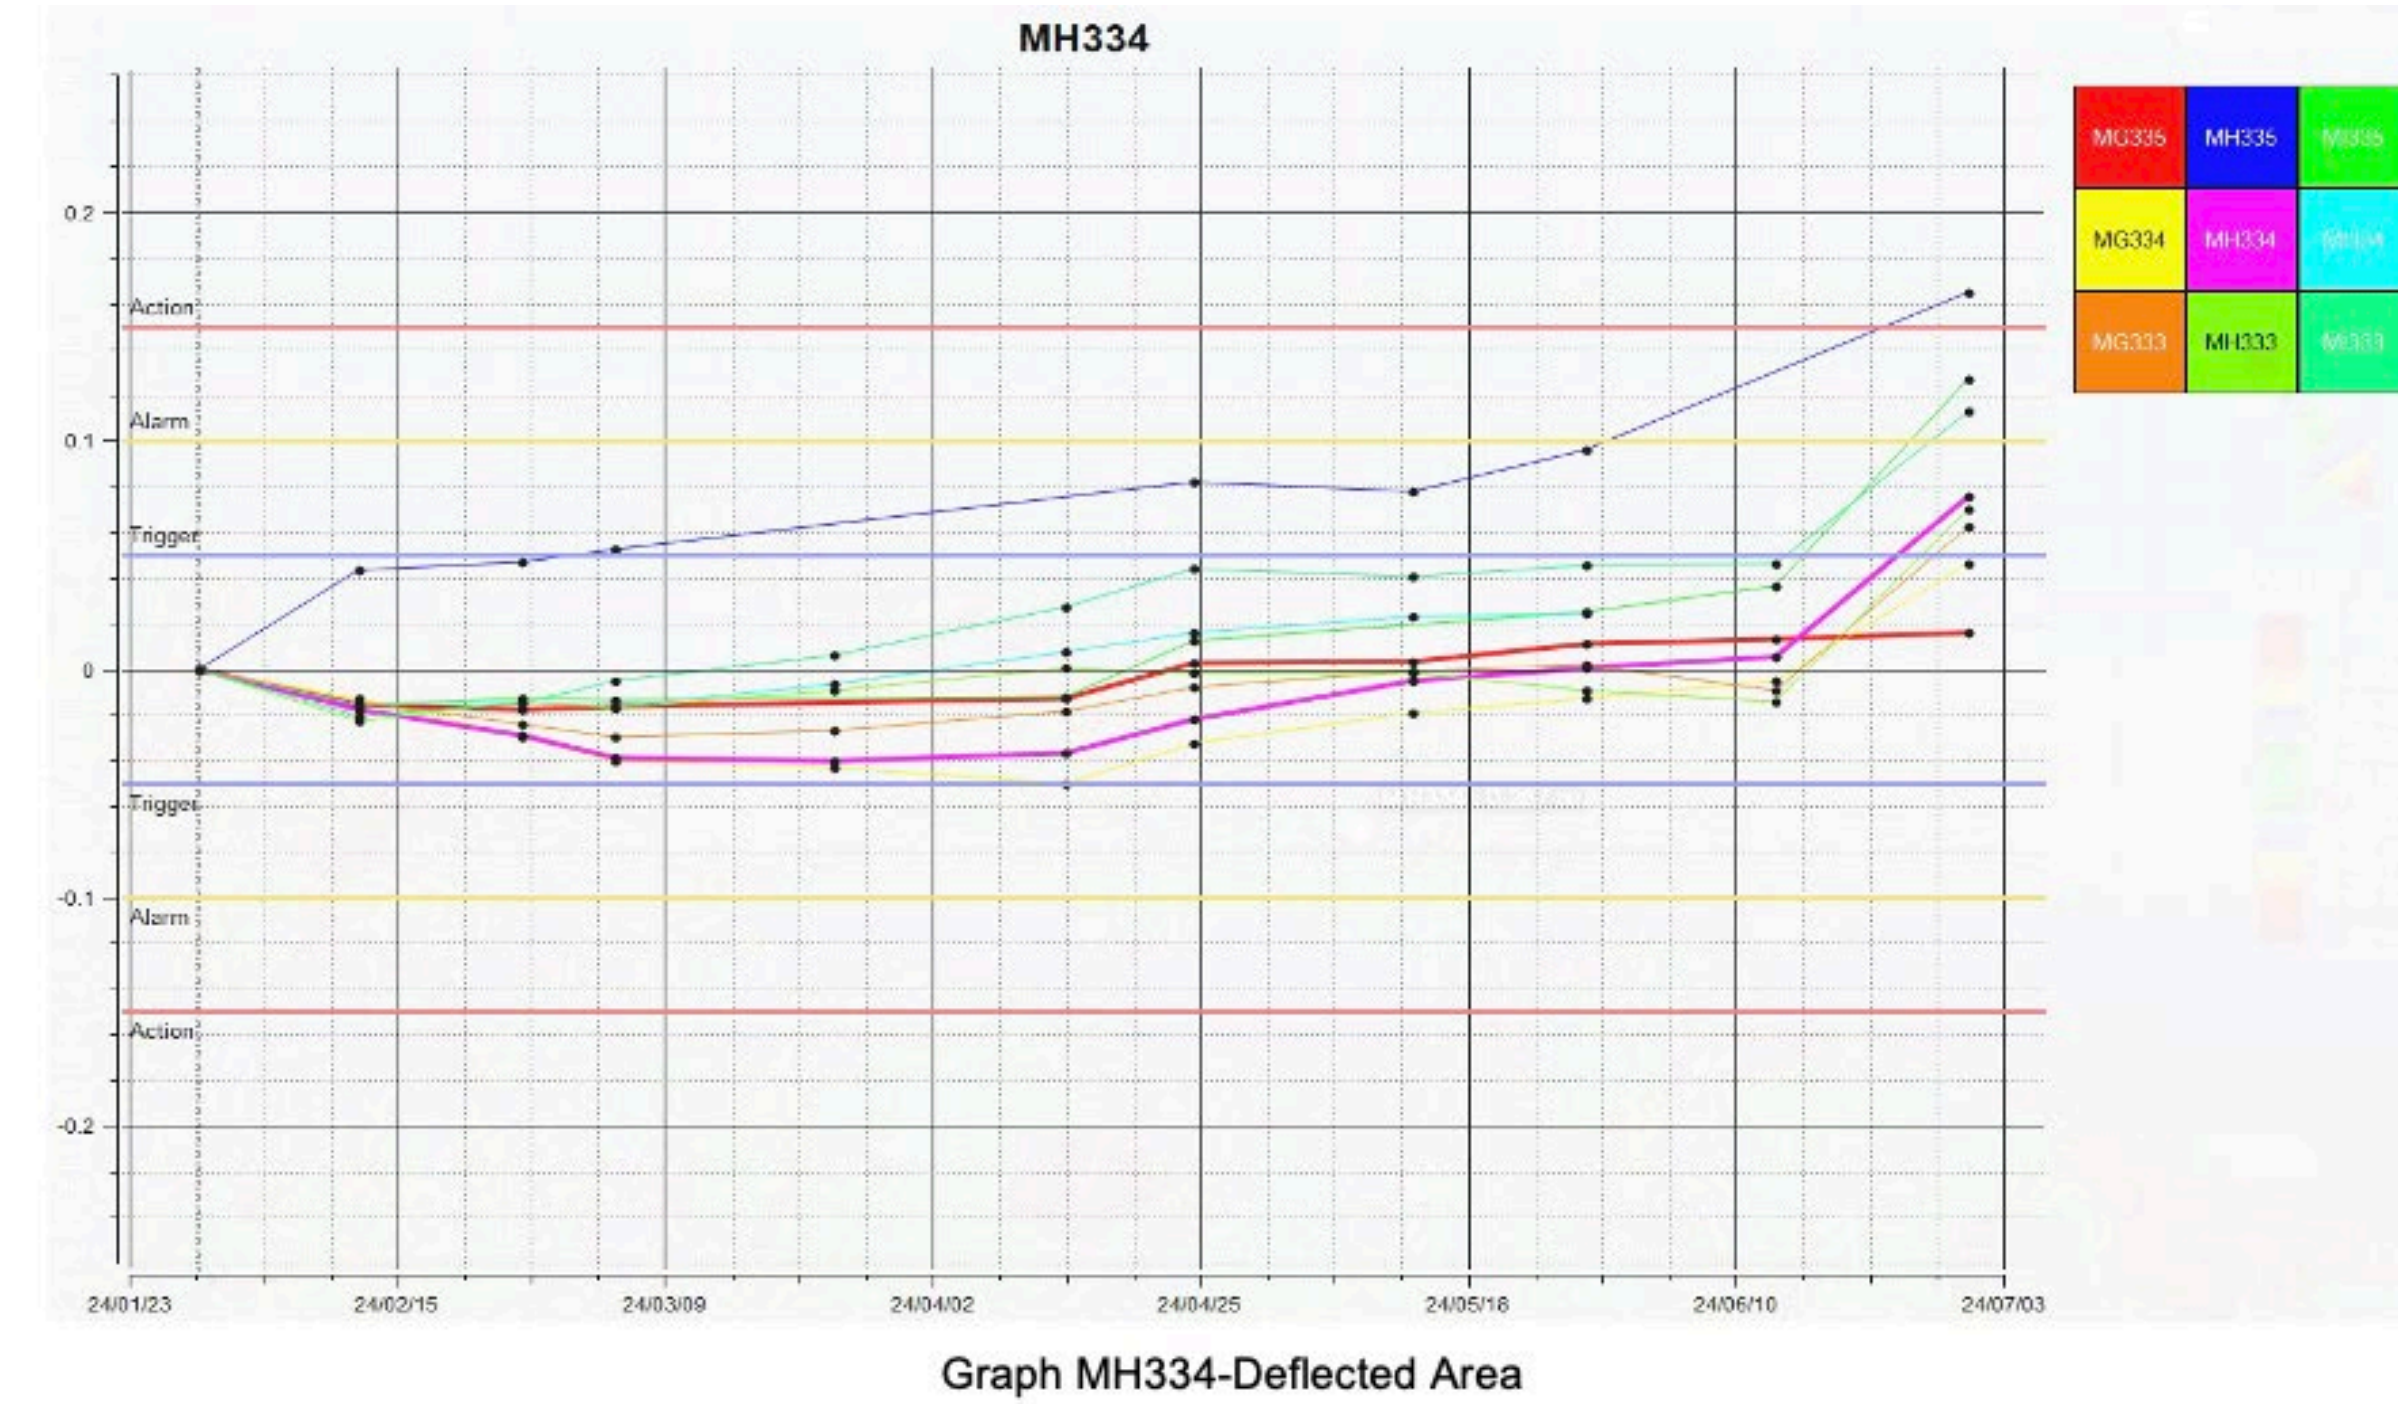
Points go Out. Rock disturbance

Additional properties	
Cell	MH334
Deviation	0.0508
Points count	2
Average Distance	0.2871
3D centroid	210.768, 70.203, 41.477
Volume of deformation	0.0081

Average 3D movement : Out 0.2871

- In Section 5, laser scanning detected that a large portion of the monolith's upper section is missing. A cloud-to-cloud comparison indicates that there is no rock left in the scanned area, signaling a critical incident.
- Specific points in Section 5, such as JH195, JJ223, LH154, LR334, and others, showed no significant 3D movement. The report highlights stable graphs, with movements recorded as minimal (ranging from 0.0455 to 0.1056 in 3D movement), confirming no major changes occurred after the rock removal.
- However, two points (MH334 and SG263) near a deflected area showed more movement, with an average 3D movement of 0.2871 and 0.0934, respectively. MH334 displayed outward movement, suggesting rock disturbance, while SG263 pointed to rock removal.

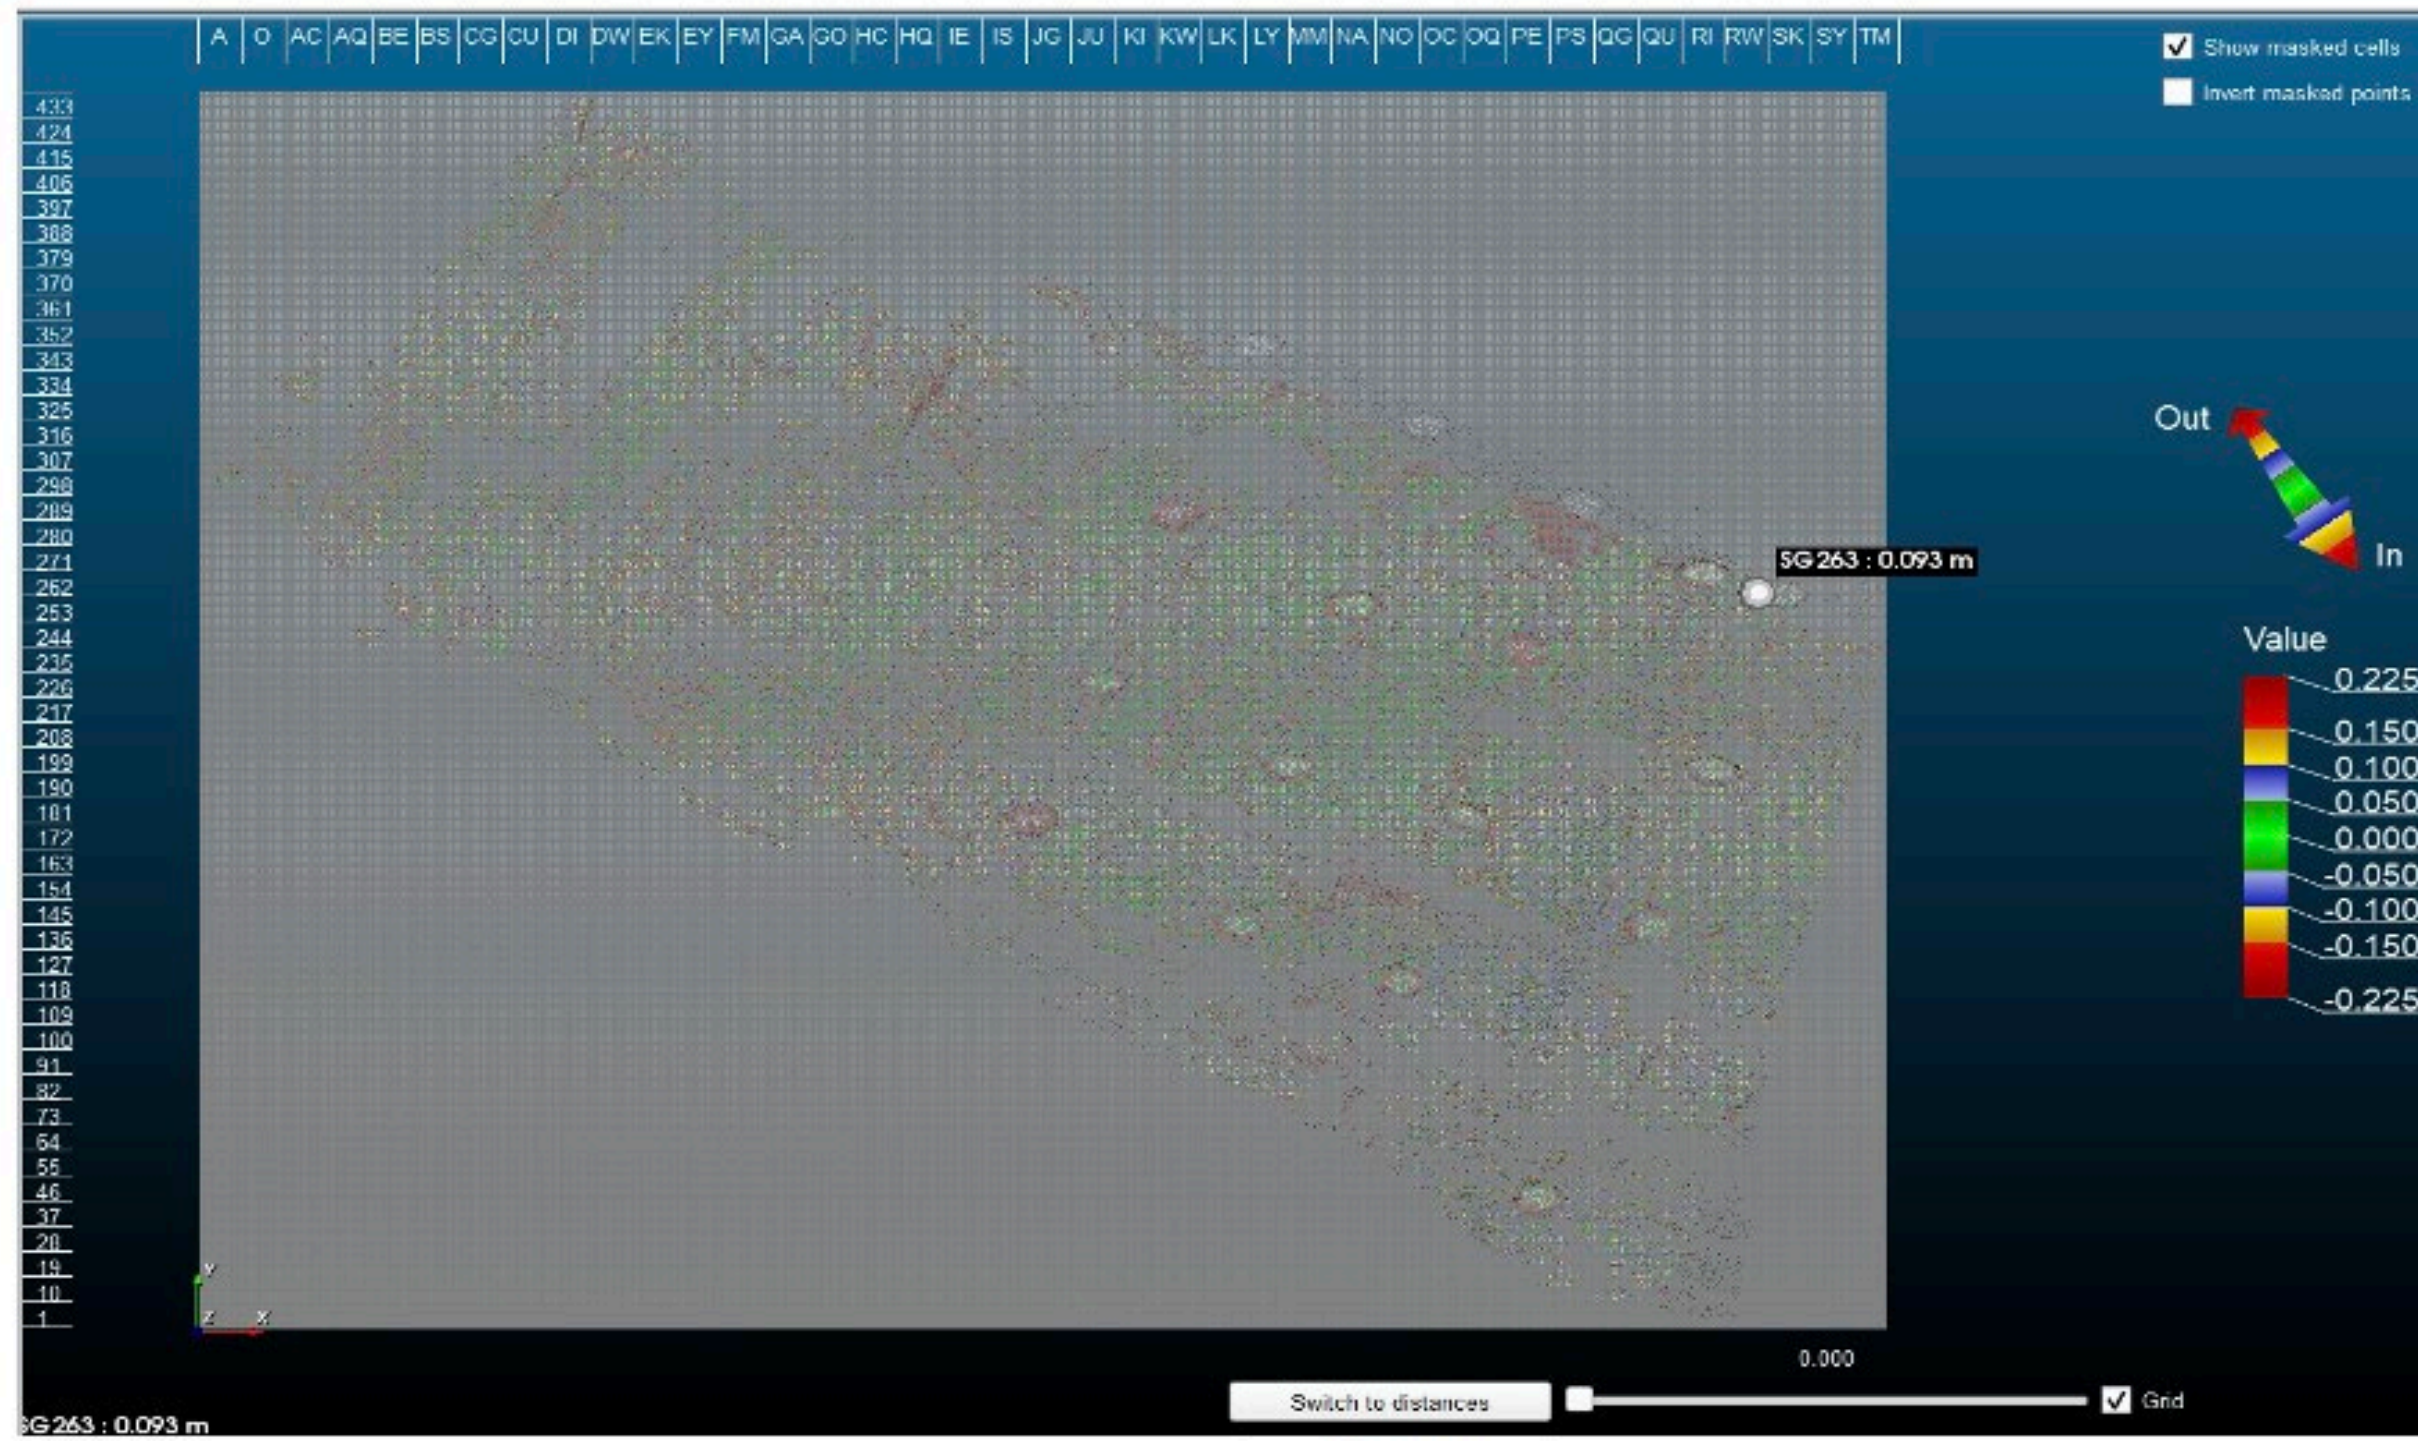
Point SG263-Deflected Area

Points go In. Rock Removal

Additional properties	
Cell	SG263
Deviation	0.0000
Points count	1
Average Distance	0.0934
3D centroid	166.954, 122.388, 39.220

Average 3D movement : Out 0.0934

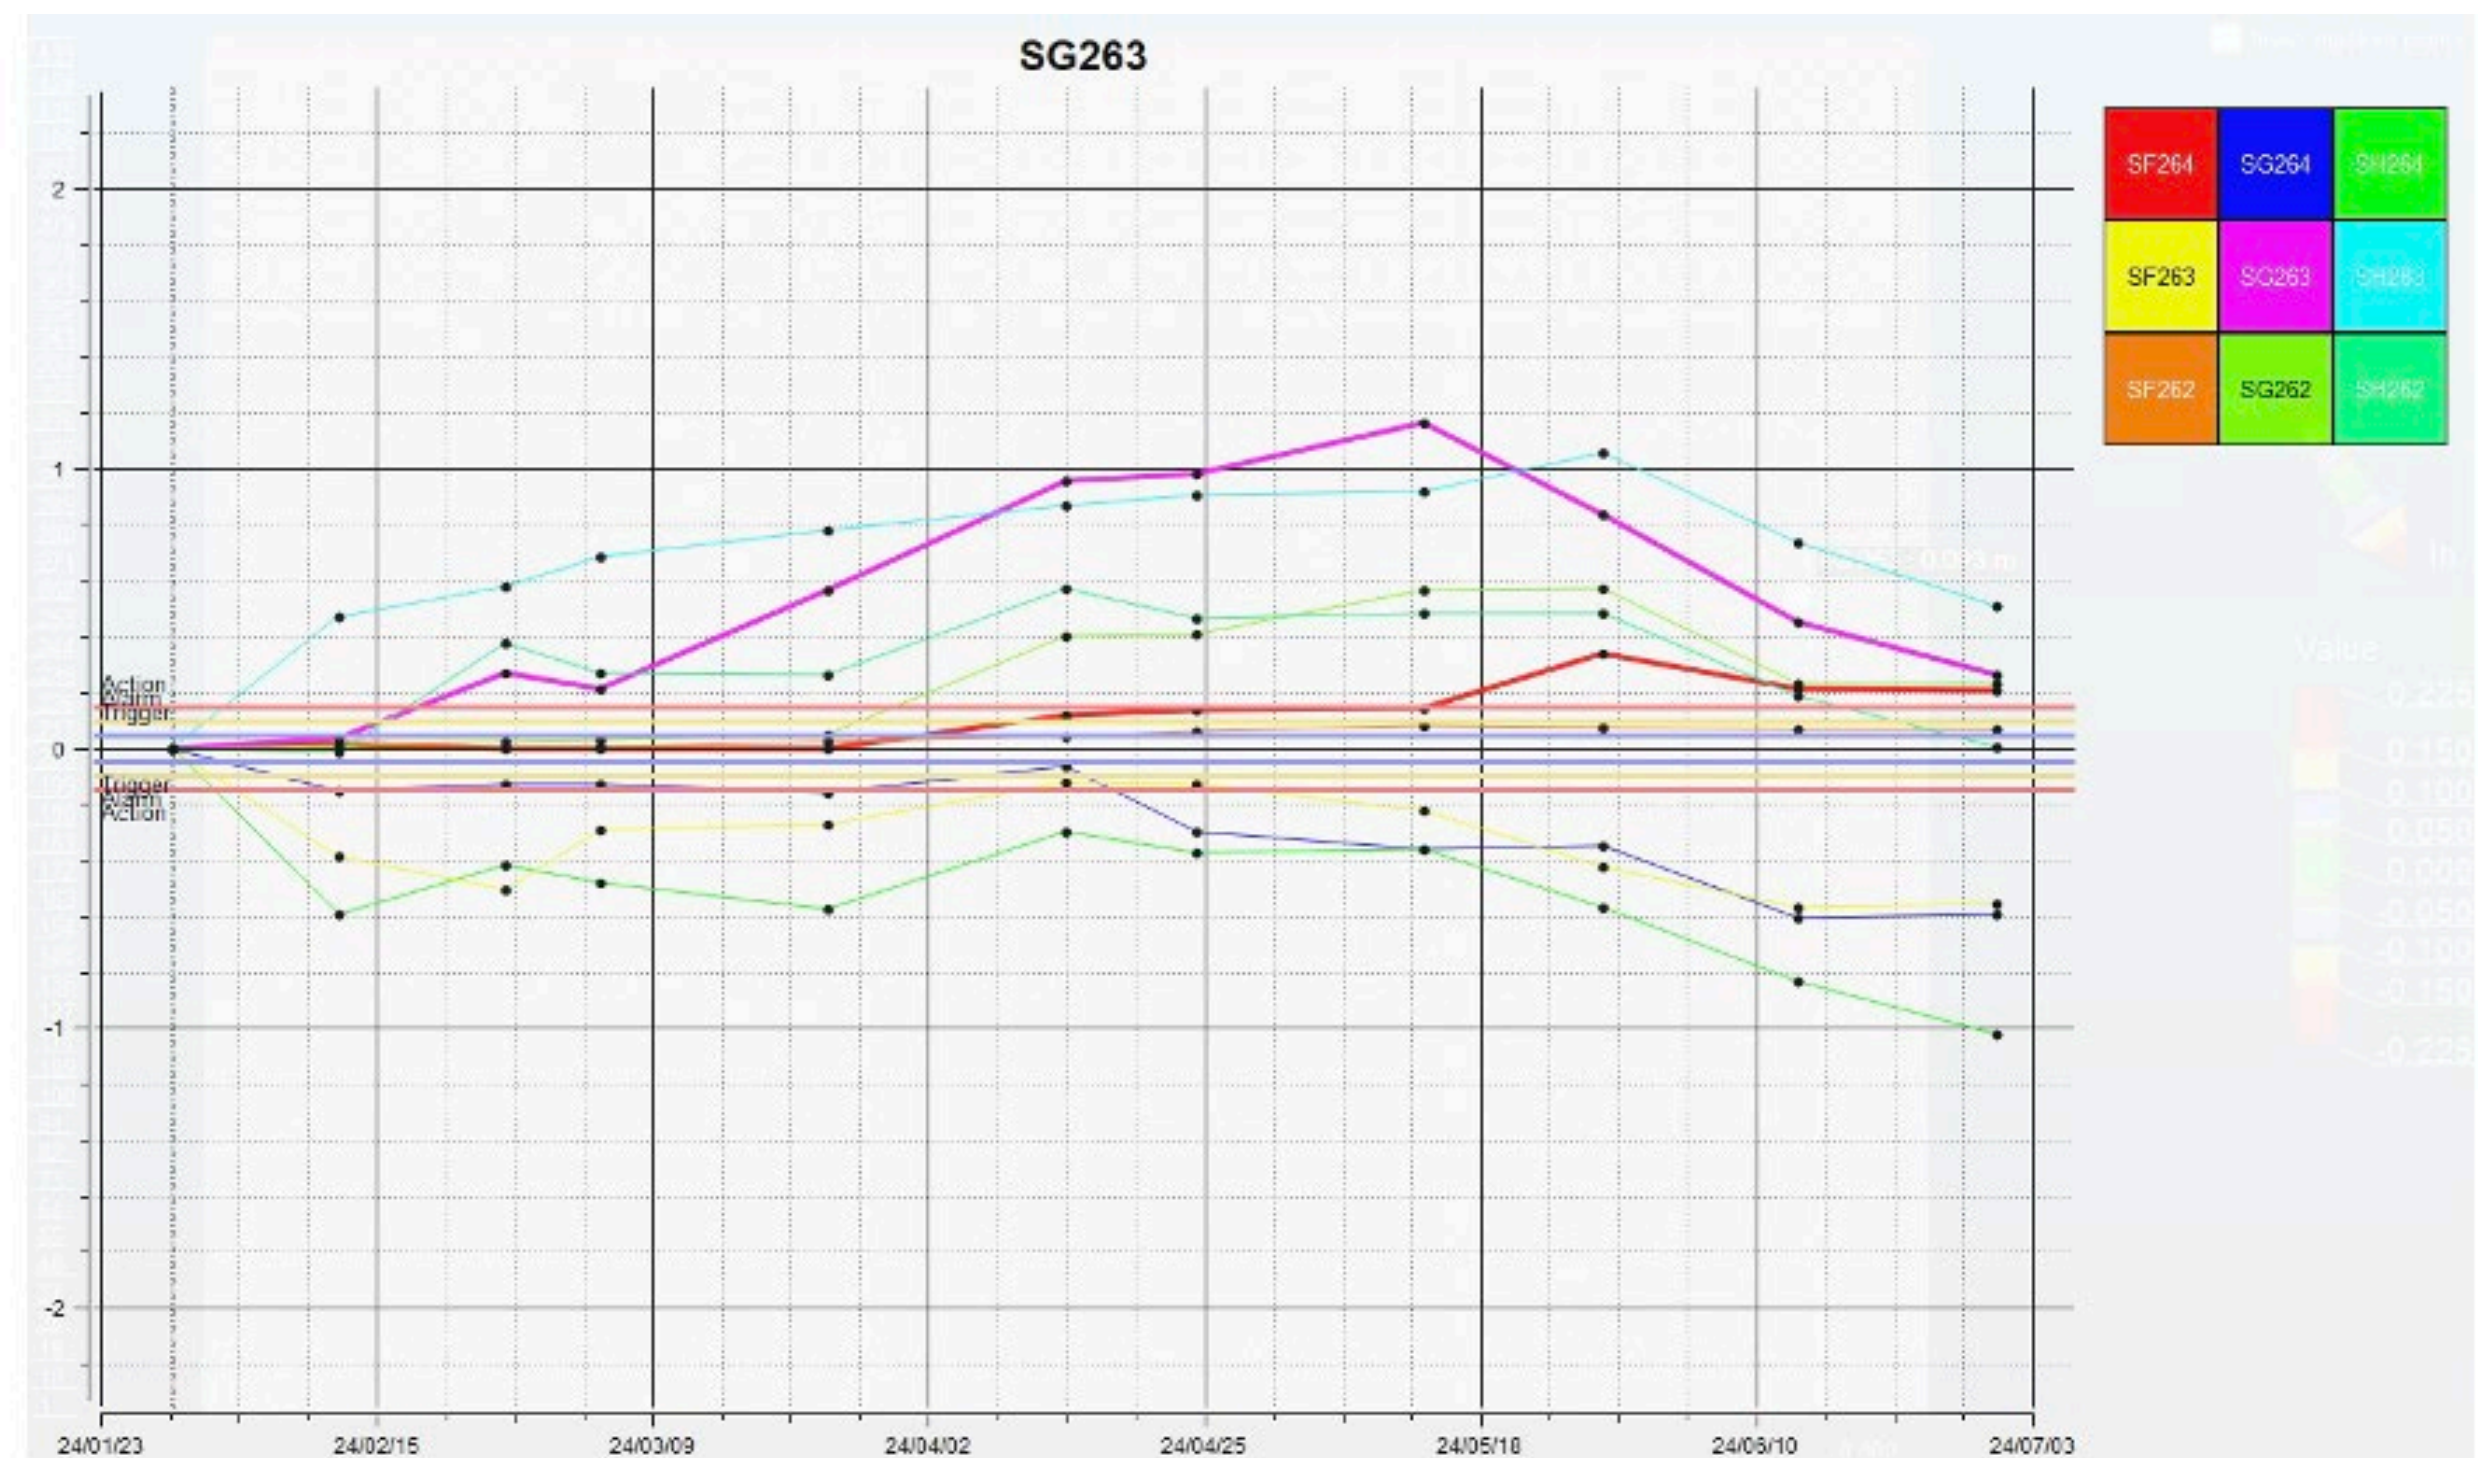
Graph SG263-Deflected Area

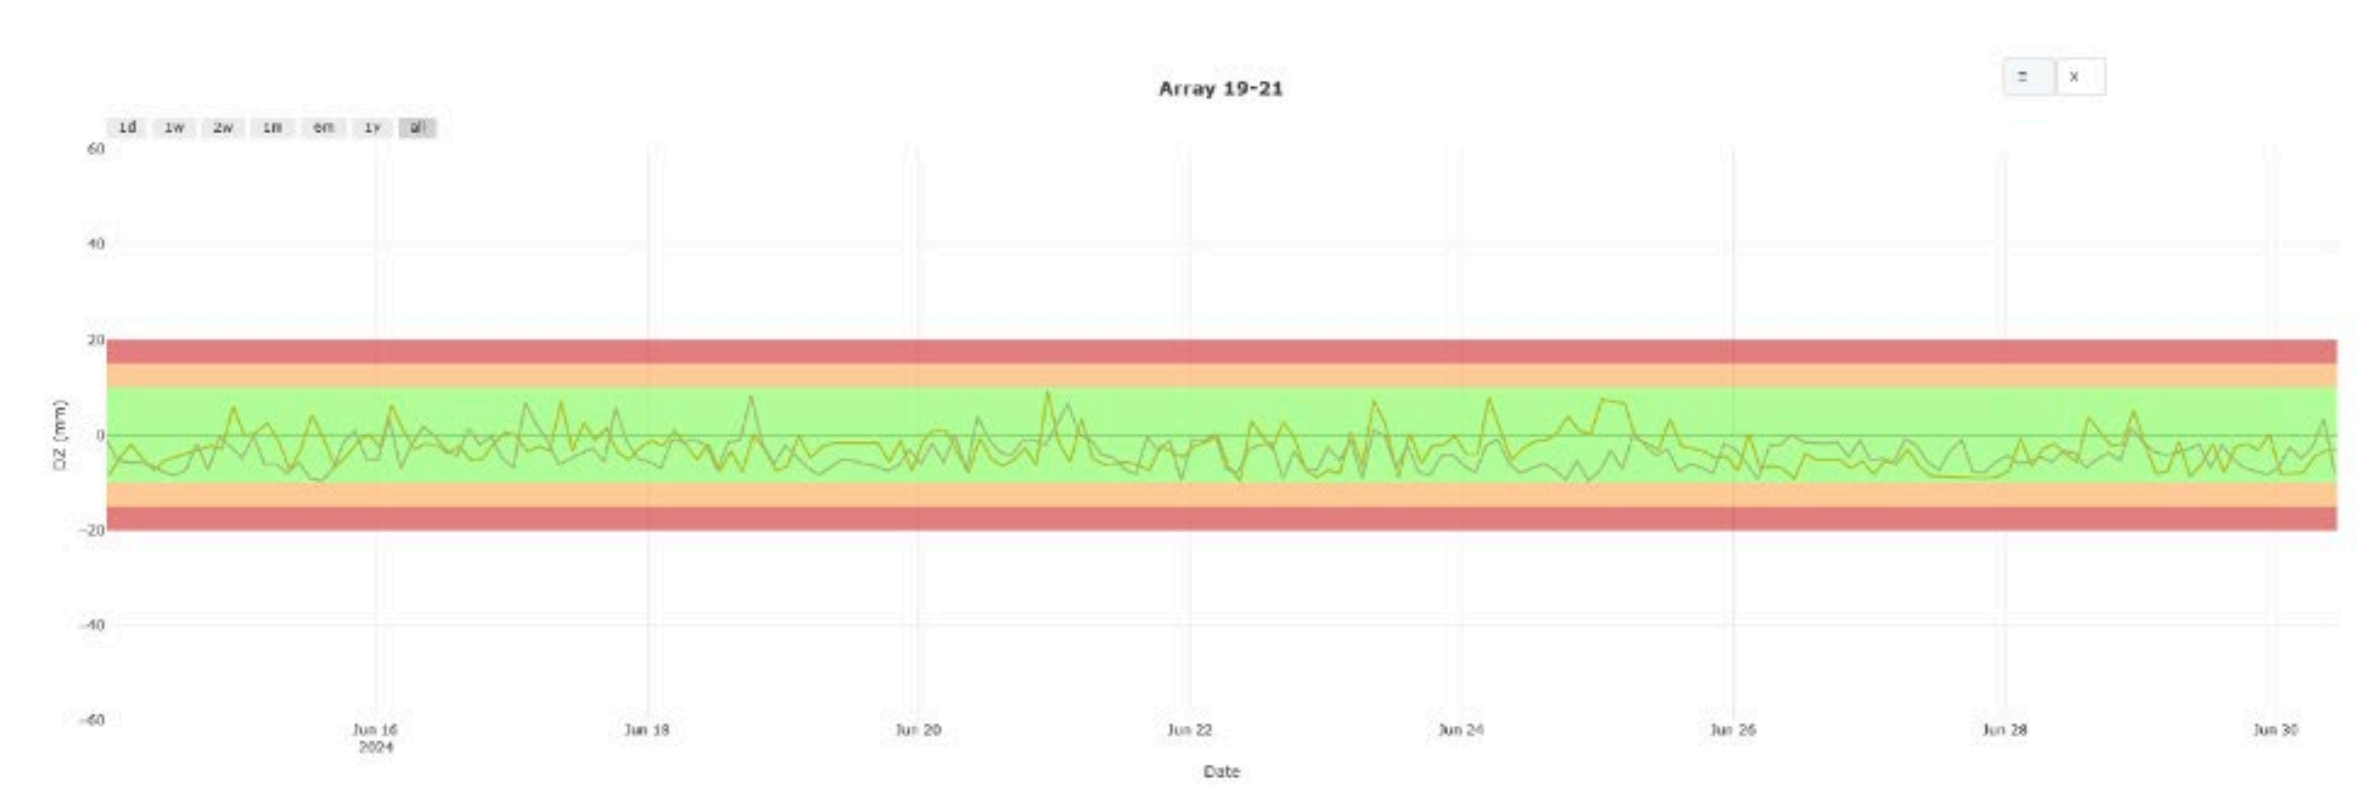
Δz Array 19 to 21, Points PT02 (Middle zone) June 13 to June 30

- The ATS was employed to provide detailed zone-by-zone measurements, corroborating the laser scanner's findings. The Δx , Δy , and Δz values across different zones (upper, middle, and lower zones) remained stable, indicating no significant movement except for the upper zone where the rock removal occurred.
- These stable values suggest that apart from the identified rock removal, the rest of Section 5 remained structurally stable and within monitoring limits.

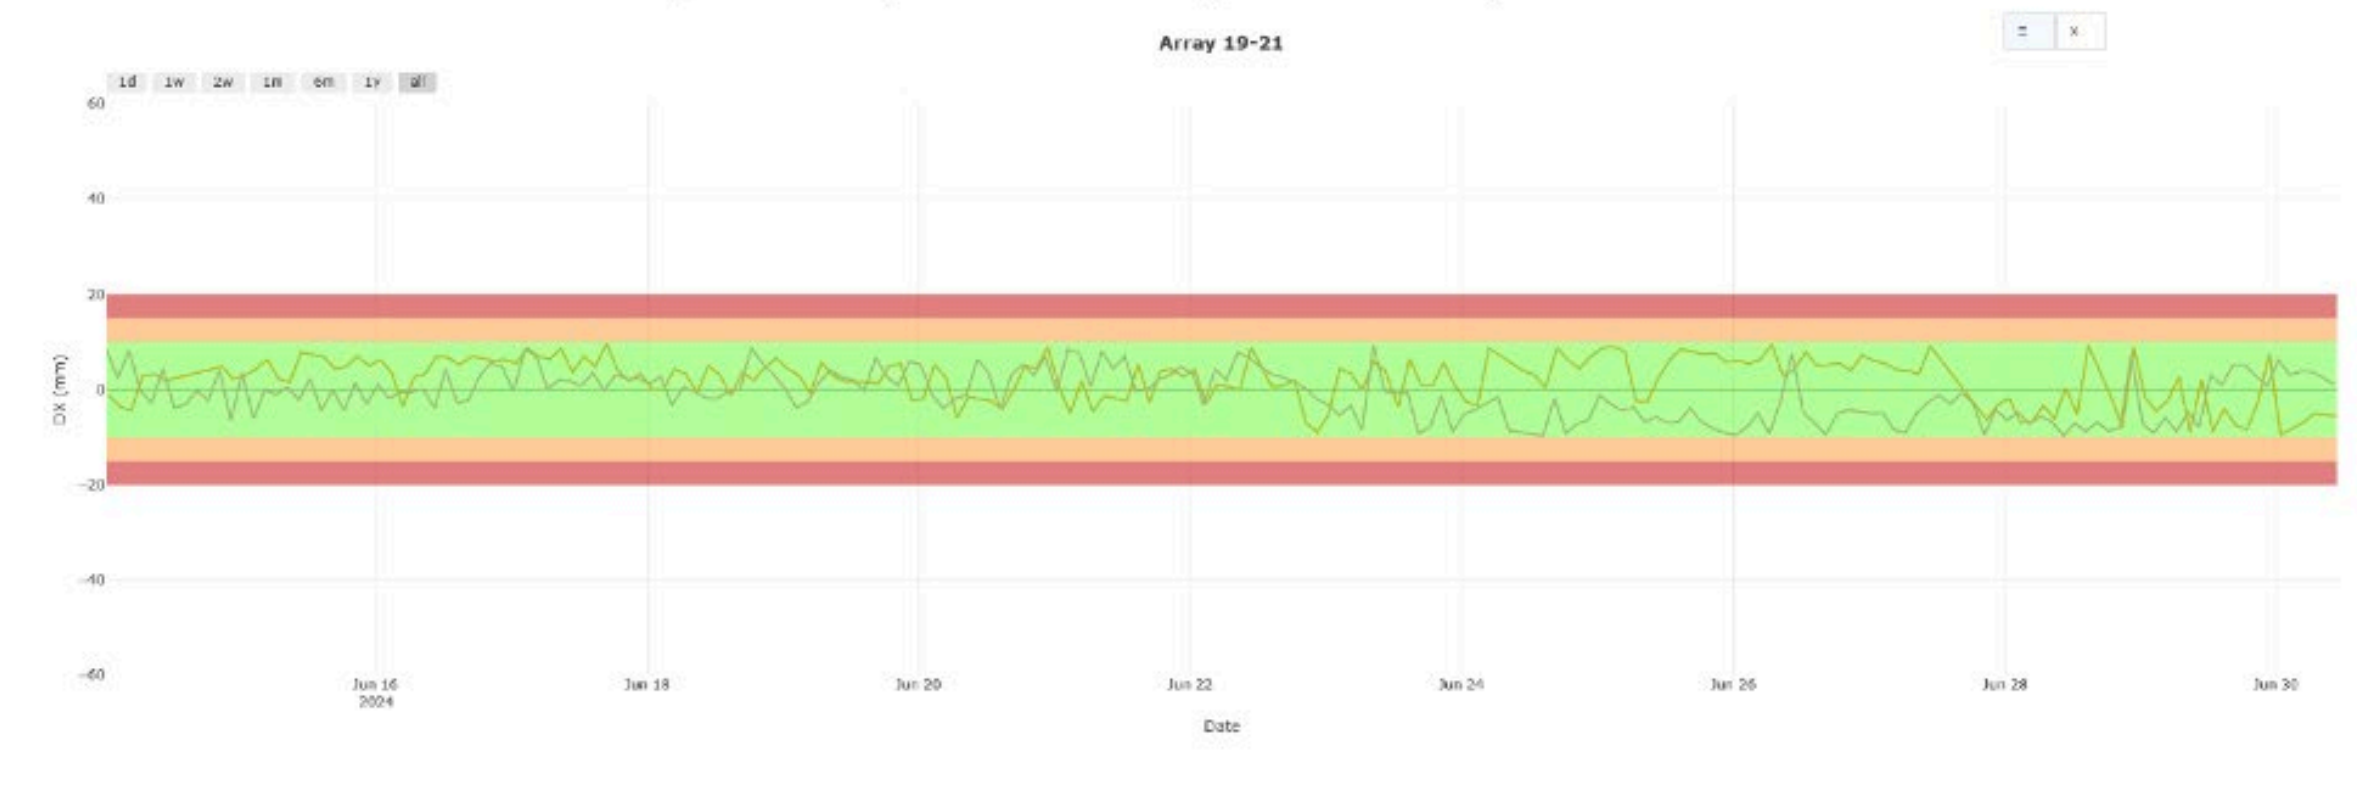
Δx Array 19 to 21, Points PT02 (Middle zone) June 13 to June 30

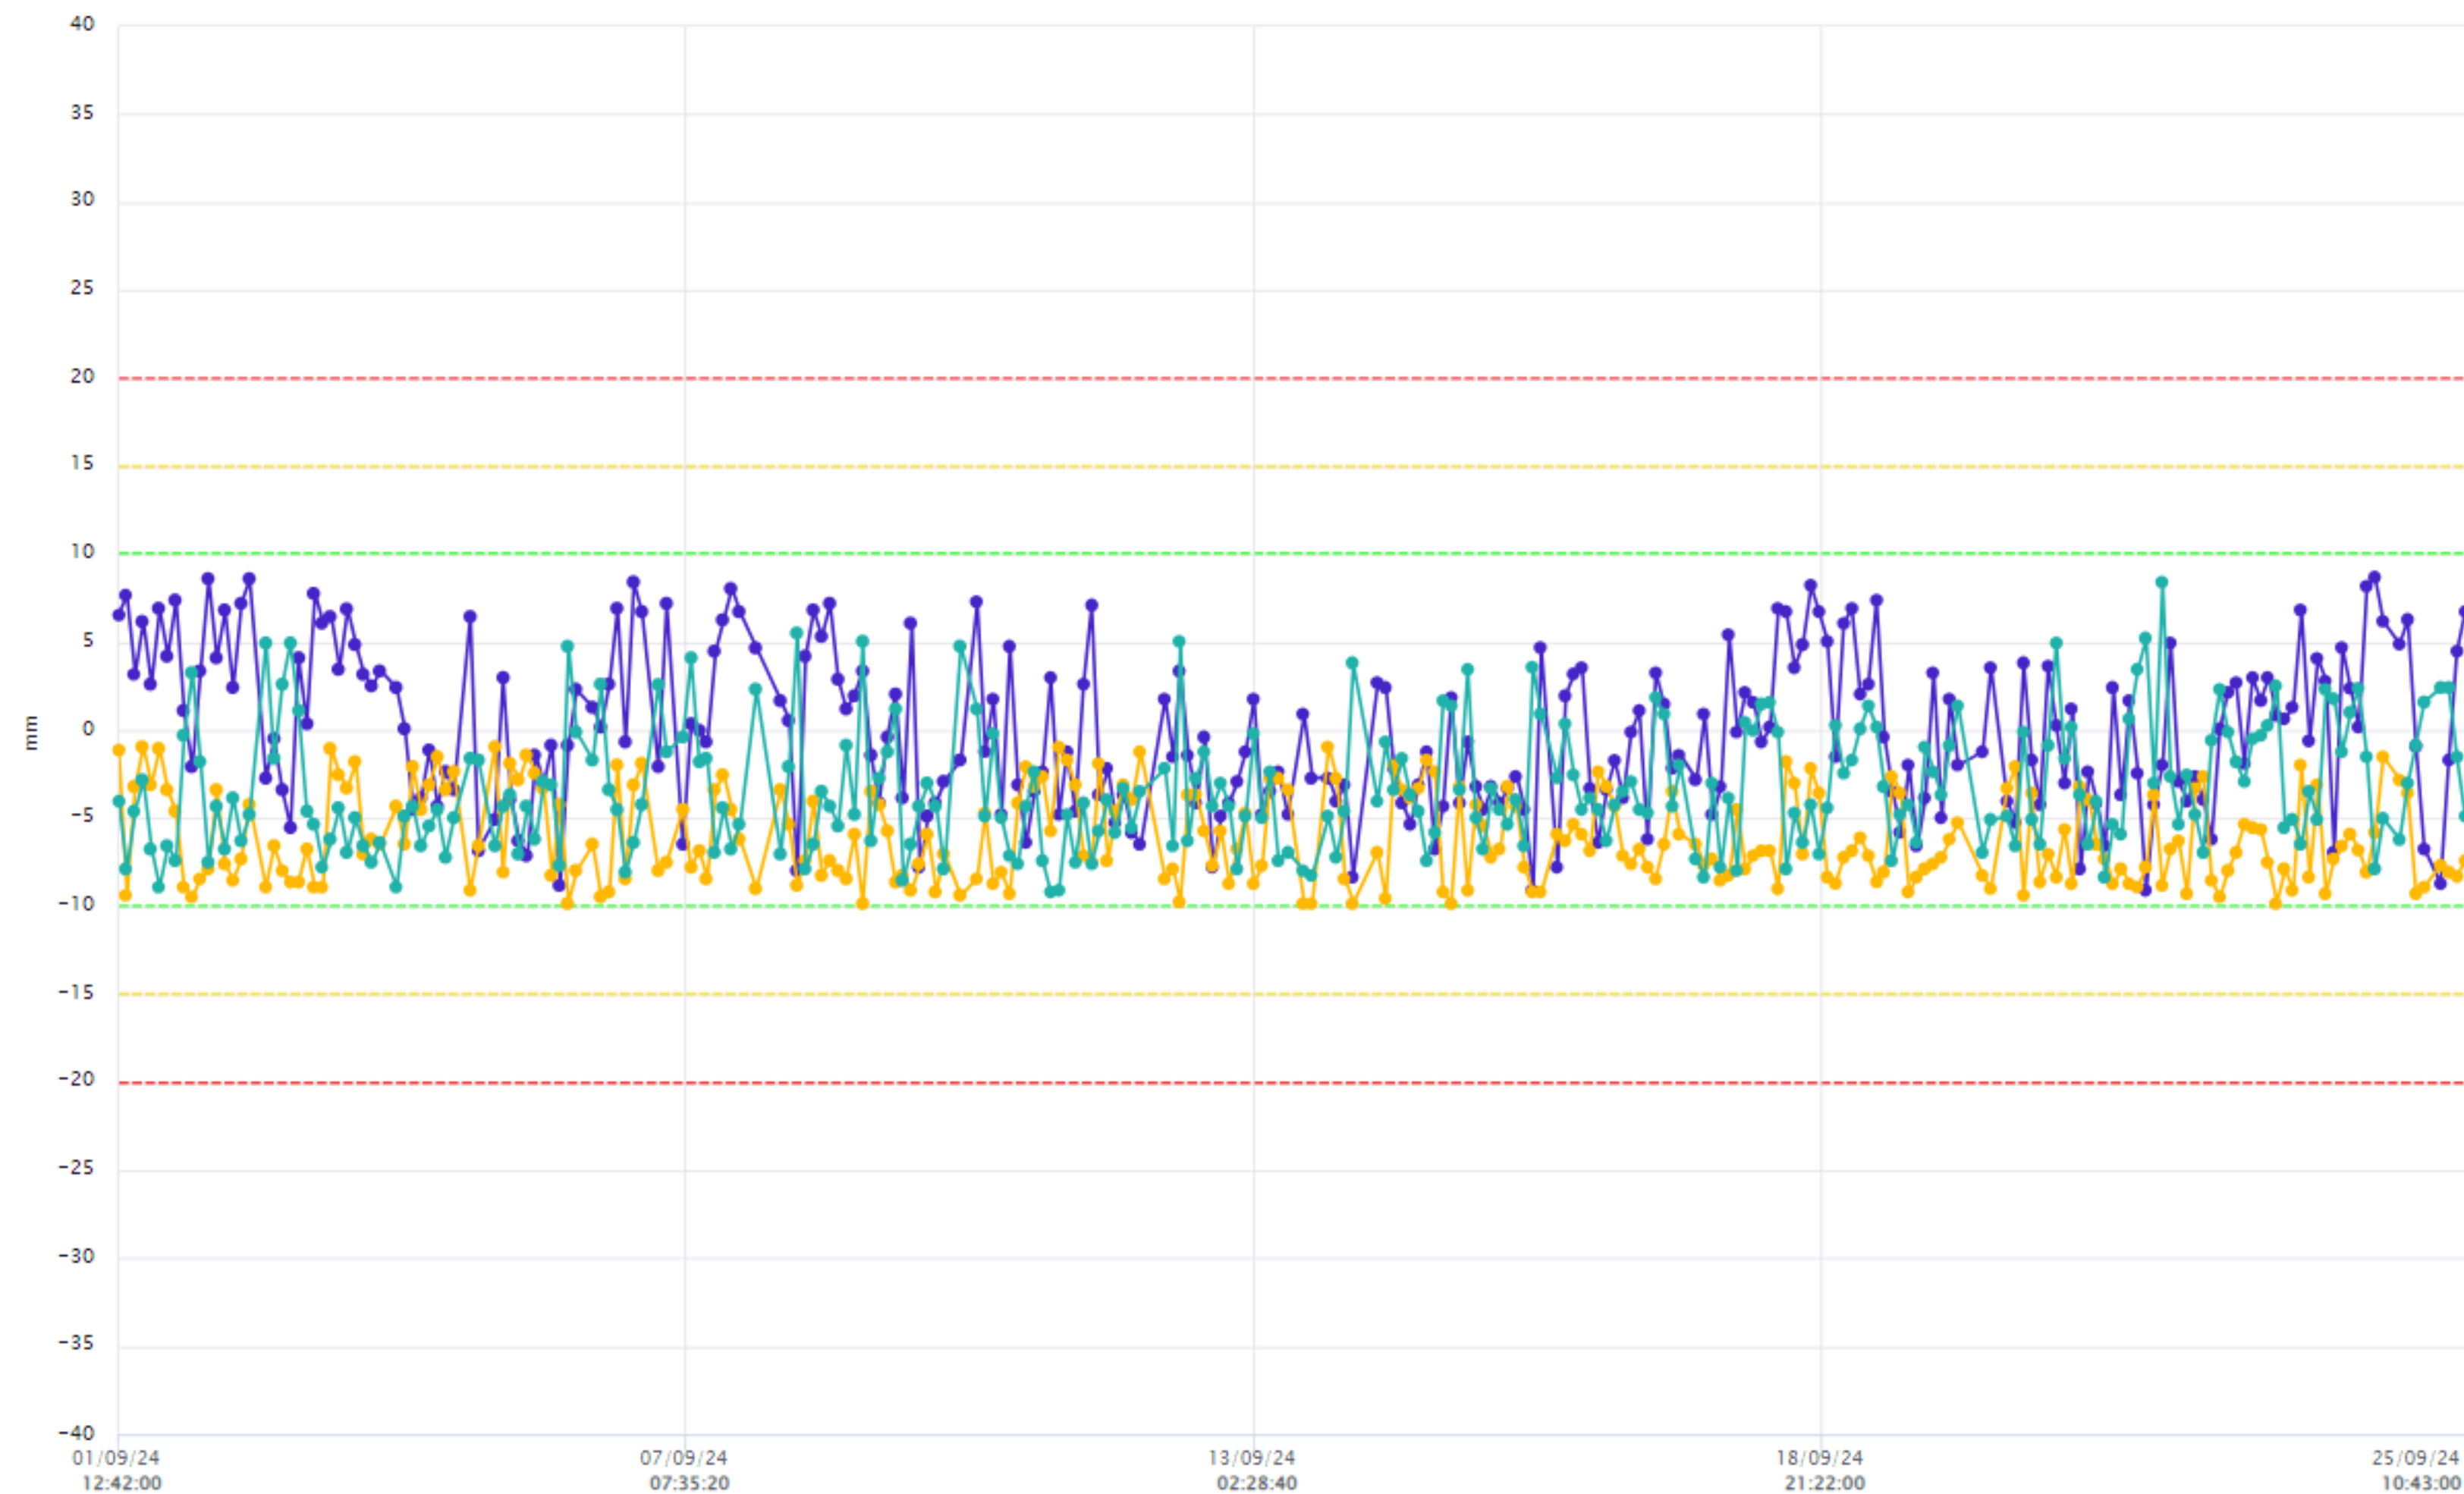
01 Sep 2024 - 25 Sep 2024

● Delta X ● Delta Y ● Delta Z

Array-03 A3-PT-03

Last reading: 25/09/2024, 10:43:00

Y 2936625.5783 m

Z 938.5342 m

Delta X 6.699 mm

Delta Y -7.4 mm

Delta Z -4.899 mm
