An Integrated Approach to Slope Stability Monitoring

Slope Stability Monitoring during Construction

- This project entails monitoring a monolith while the top is being blasted for the construction of a seven-star hotel.
- The presentation will focus on the slope stability monitoring part of this project

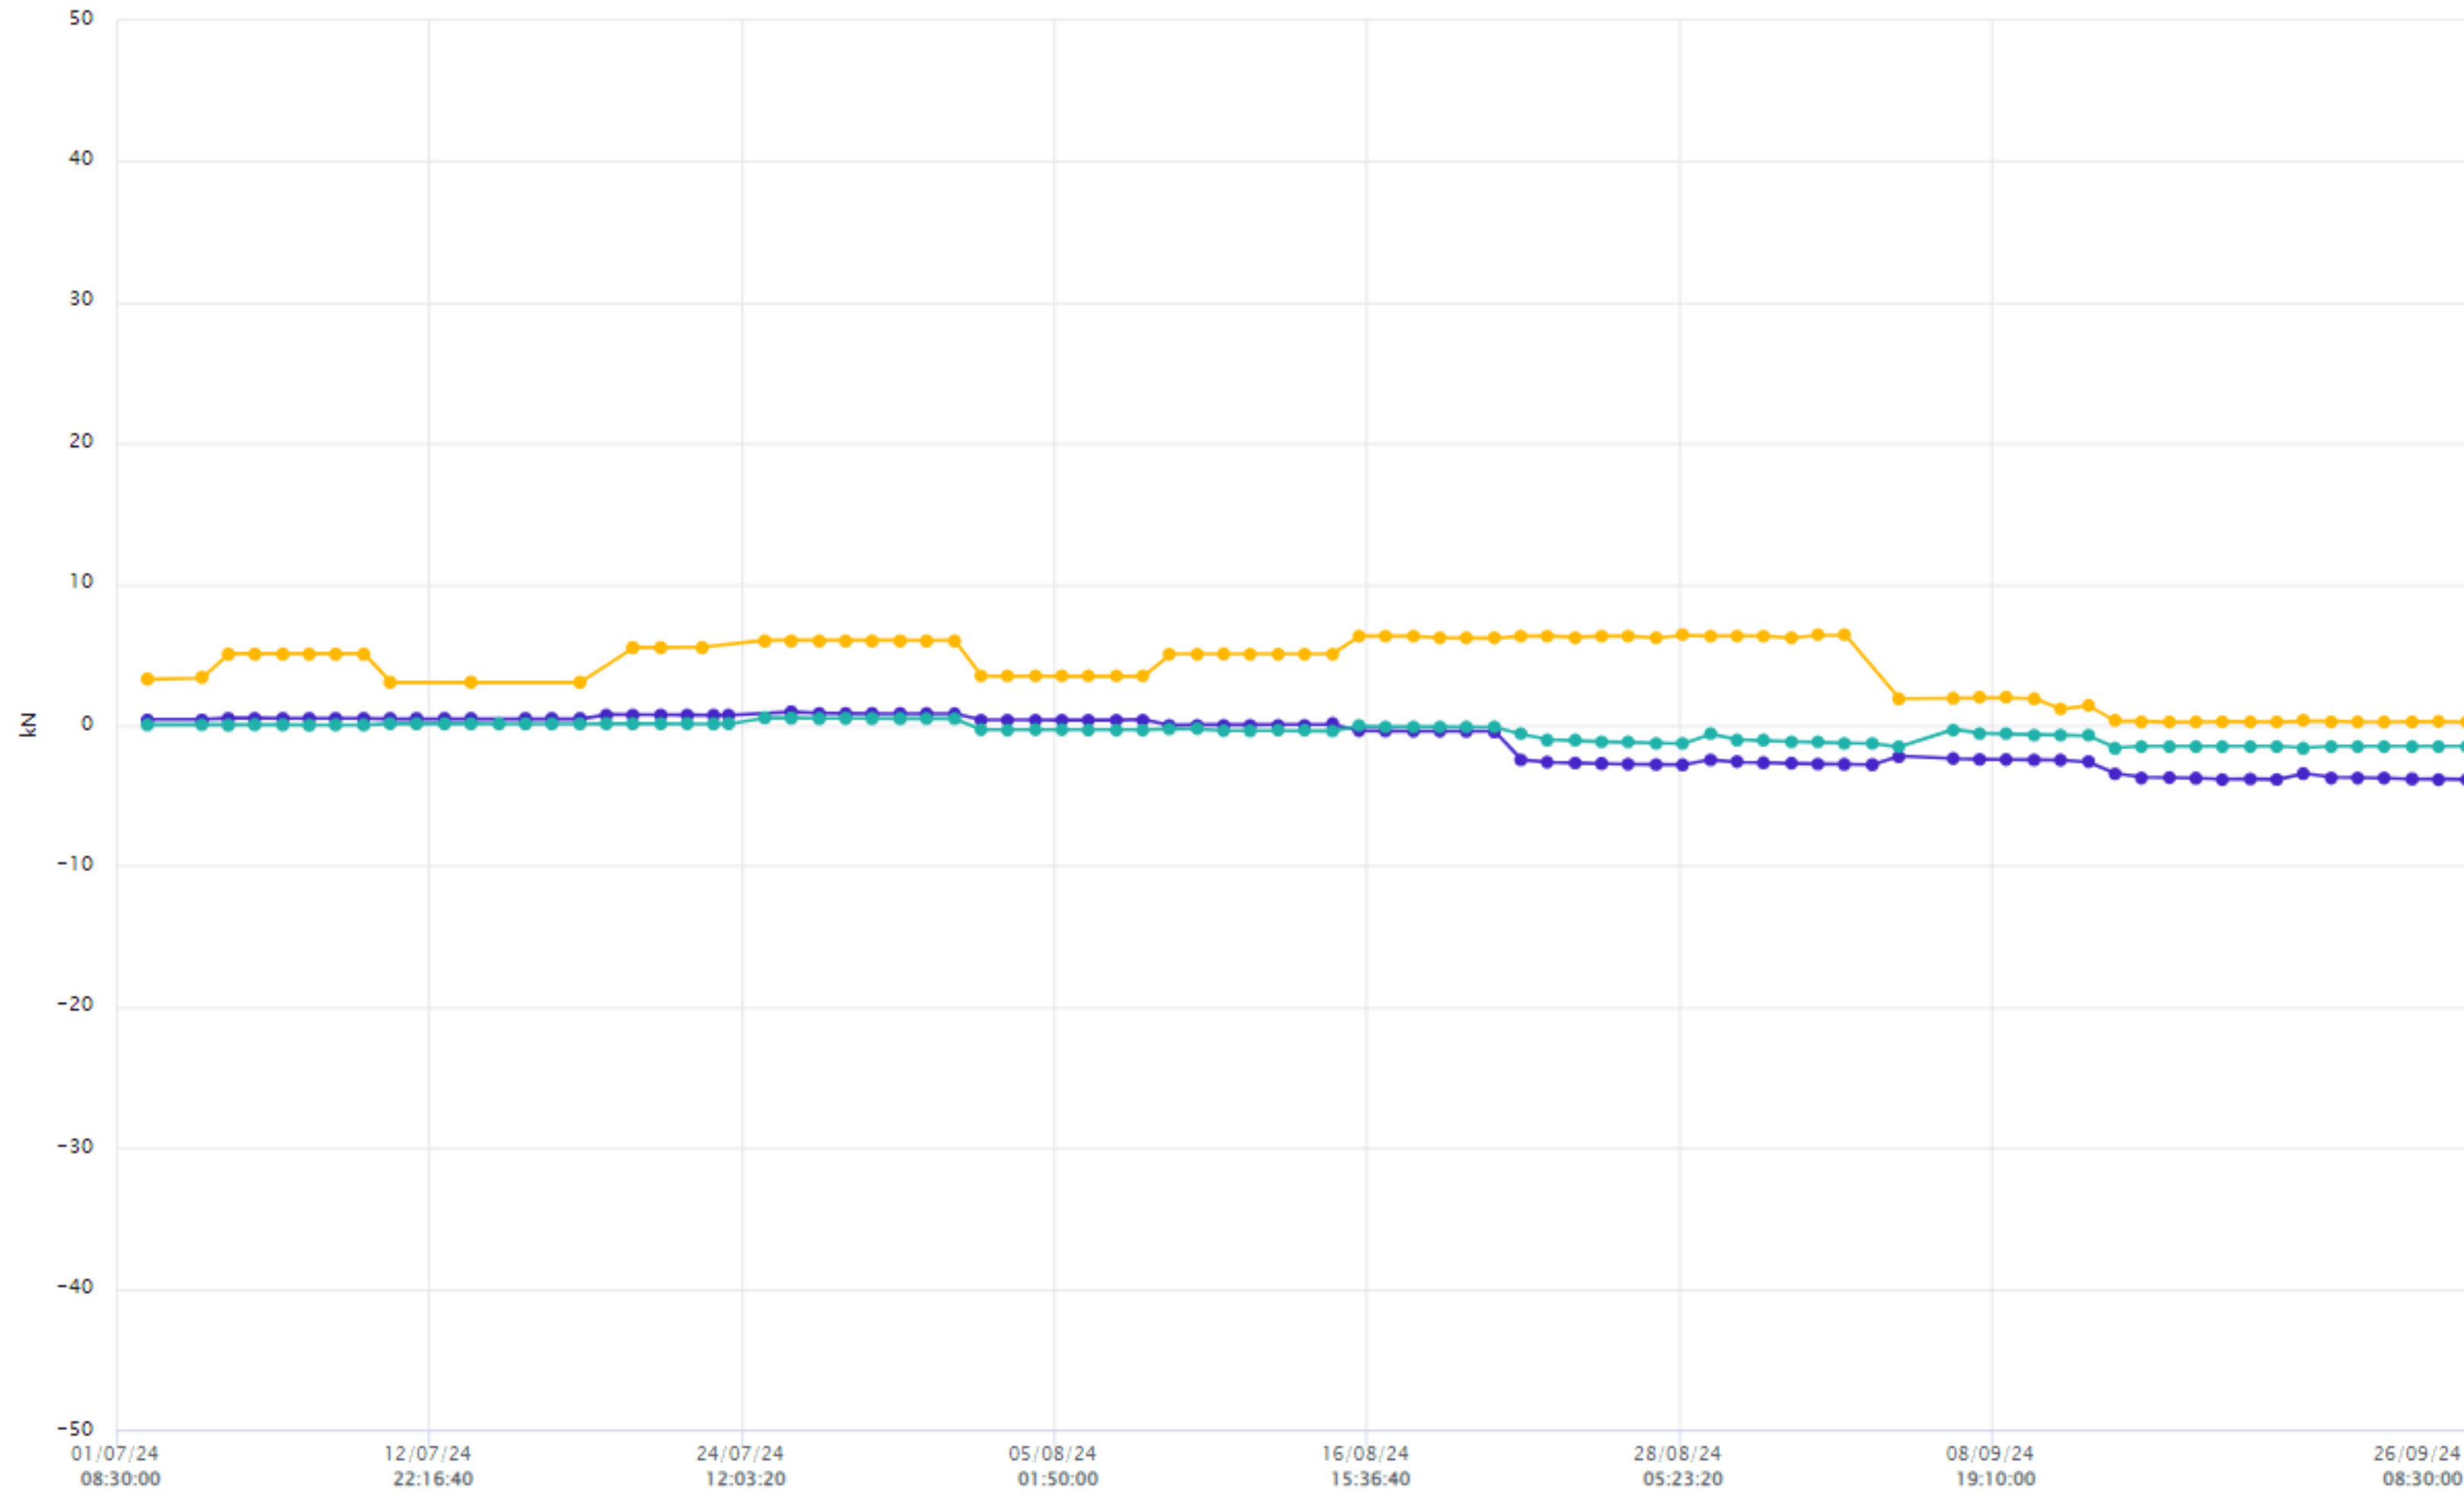
Strain Gage

01 Jul 2024 - 26 Sep 2024

F09-SG-RB-09 (Load (kN)) F08-SG-RB-01 (Load (kN)) F09-SG-RB-11 (Load (kN))

Instrument: F09-SG-RB-09

Load (kN): -3.84784 kN

Instrument: F08-SG-RB-01

Load (kN): 0.21154 kN

Instrument: F09-SG-RB-11

Load (kN): -1.49531 kN

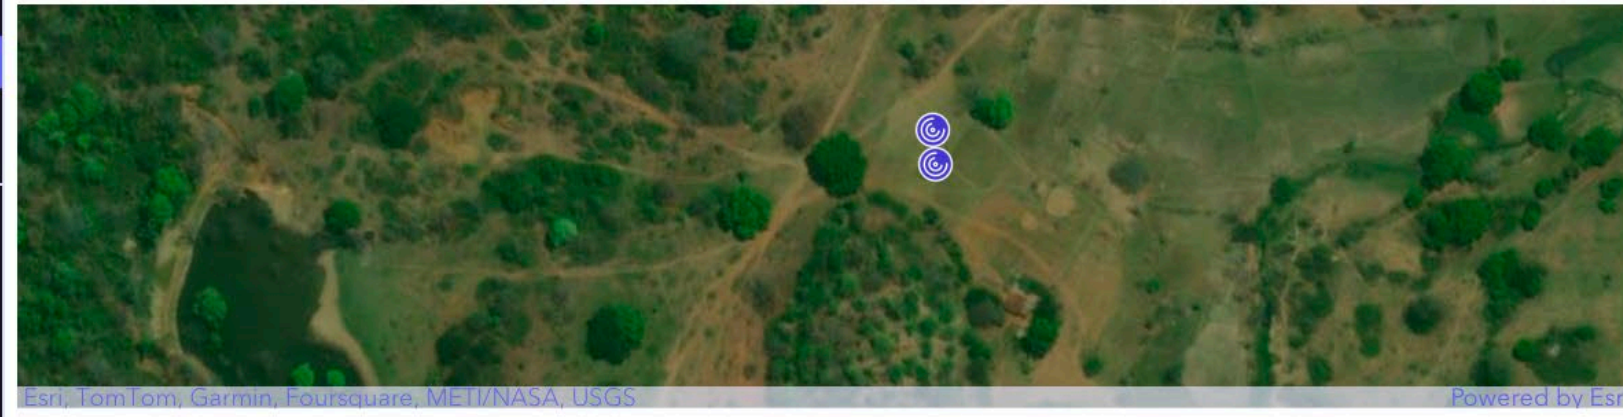
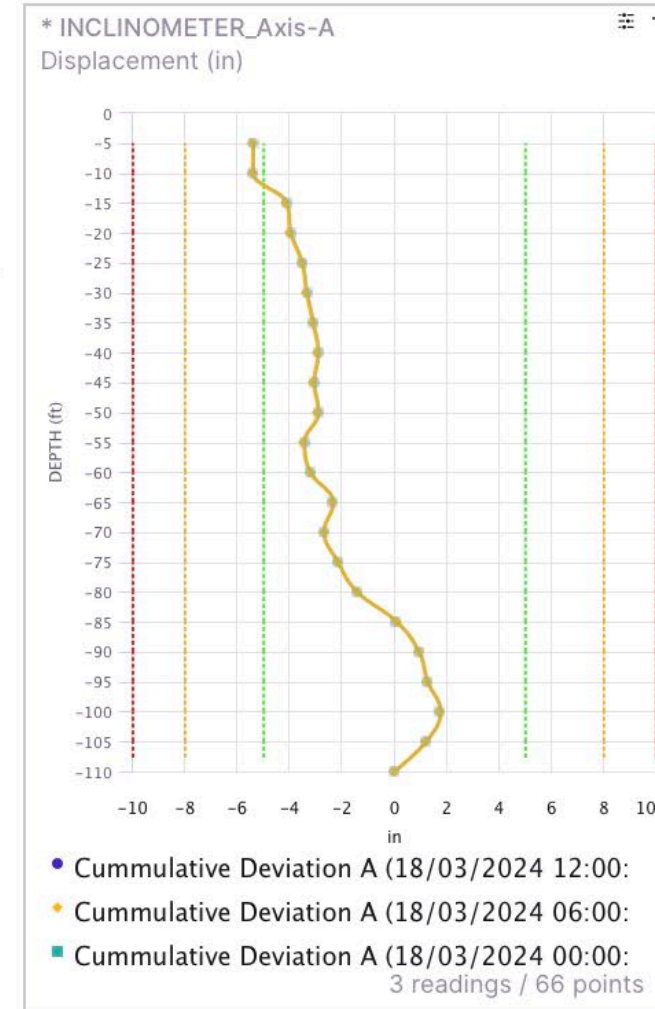
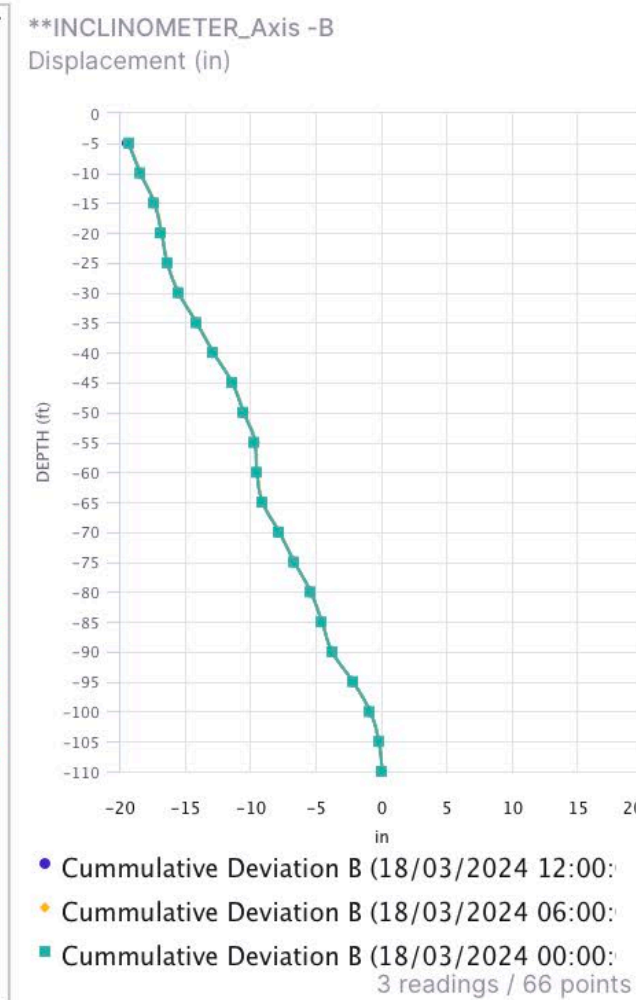
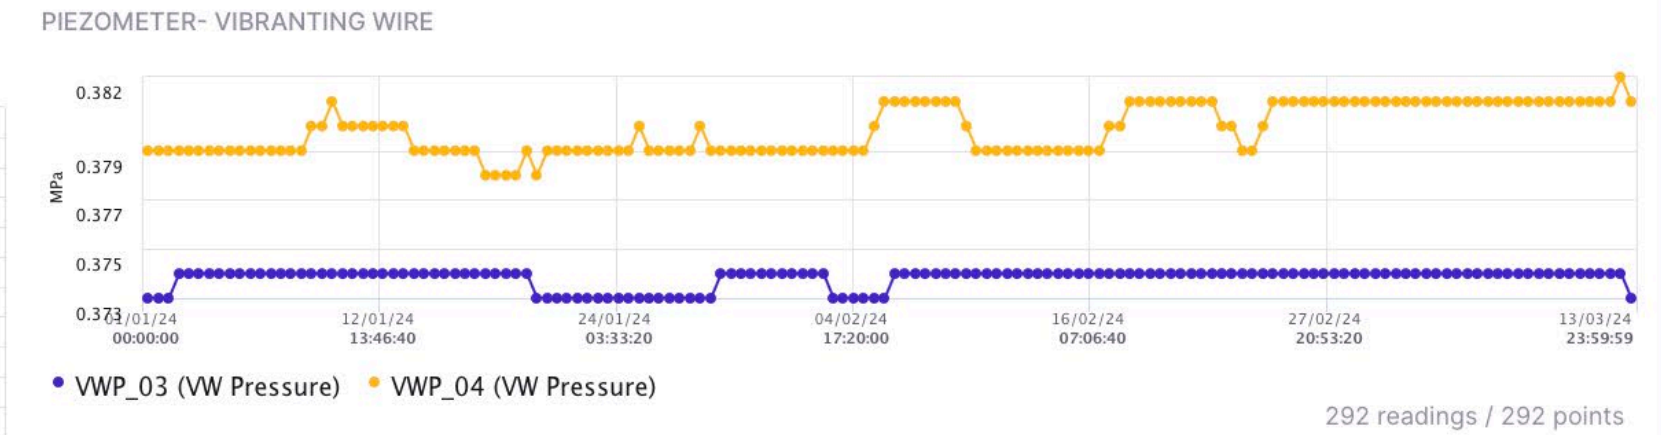
DEMO TAILING DAMS

* (+) Water Side (Downstream Side). The downstream side is opposite the tailing side and faces away from the mine. This side is often exposed to the natural environment and is crucial for the structural stability of the dam.
 ** (+) = 90 deg. Towards Water Side (Downstream Side)
